Van Alstyne, Texas Municipal Space Needs Study

December 12, 2016

Van Alstyne Municipal Space Needs Study

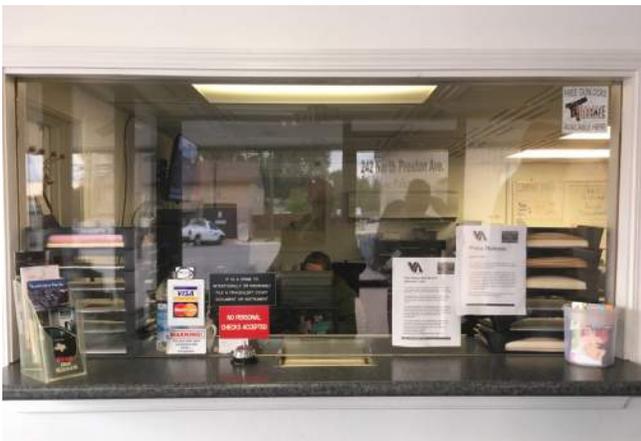
- There is not adequate ballistic glazing security protection at the records and dispatch windows.
- There is no secured staff parking lot.
- Although existing booking and holding is minimal, the lack of a vehicle sally port adds to the deficient processing sequence within the building.
- There are no interview rooms close to the public lobby causing travel through secure staff areas.
- There is not a separate secured staff entrance for safety. Most staff come through the front door.
- There are no dedicated staff locker rooms and fitness areas in the current building.
- Large item evidence storage occurs across the street and does not allow for good chain of custody.
- The only restroom is in the public lobby causing security issues for staff

Lobby transaction window looking into dispatch

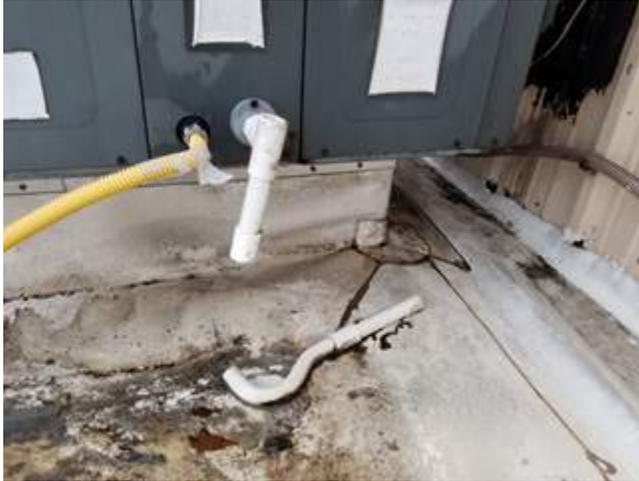
The packaged rooftop units both use R22 which is going out of production in 2020. The units need to be replaced within the next five to ten years. The Goodman packaged unit has a broken condensate pipe. The condensate pipe needs to be replaced and the waste needs to be routed to the existing scupper.

Broken condensate pipe

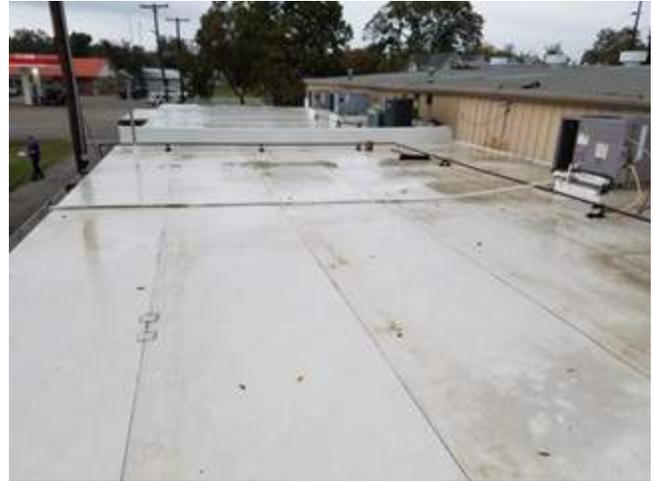
Condensate piping

The condensate drain piping for the packaged units is not properly supported or sloped. MEPCE recommends installing pipe supports.

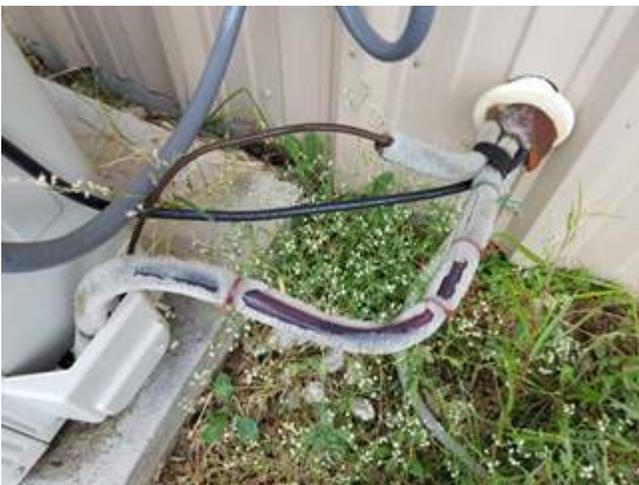
The 1.5-ton condensing unit has damaged refrigerant piping insulation. MEPCE recommends replacing the damaged insulation. MEPCE recommends providing aluminum jacketing for the exposed refrigerant suction line insulation on the new condensing units. Aluminum jacketing will protect the insulation and ensure the condensing unit continues performing efficiently.

Damaged refrigerant insulation

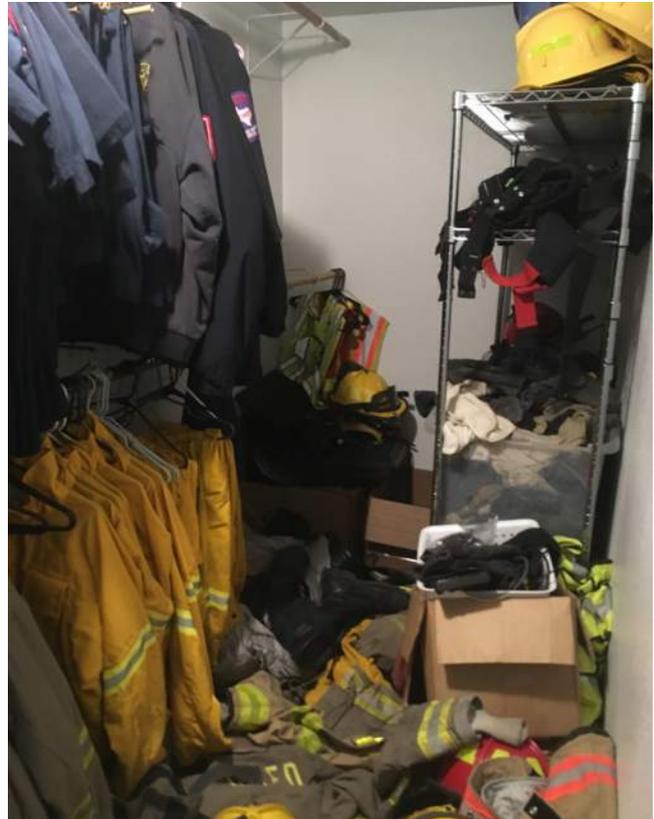
Inadequate gear storage

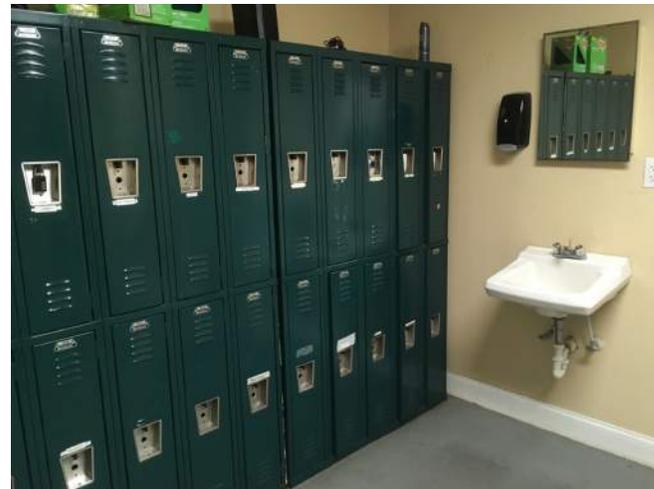
Shared locker and restroom

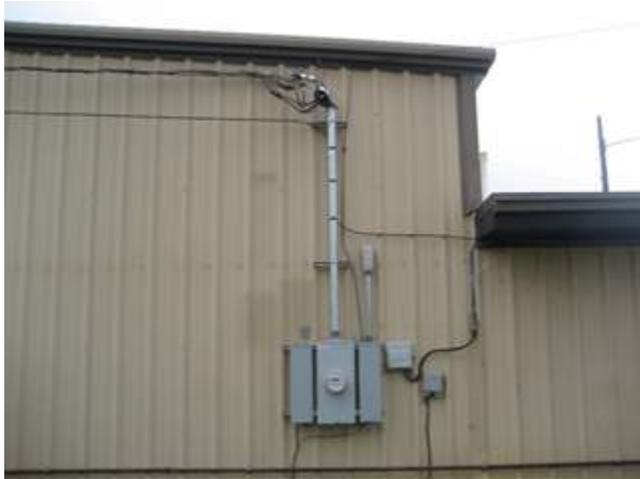
The main distribution panel with a capacity of 200A at 120/240V is in an inaccessible electrical closet within the Fire Department truck bay. This panel delivers power throughout the entire Fire Department space.

Electrical Service Entrance

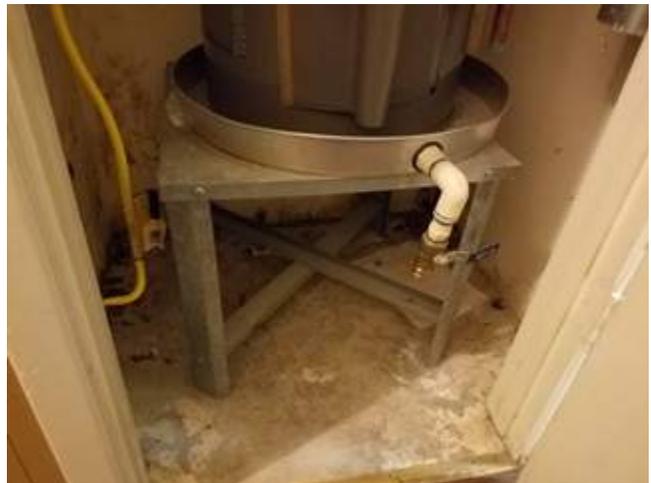
The water heater temperature and relief valve is routed directly into the drain pan. The drain pan valve is routed to the floor. This current configuration could cause damage to the flooring and walls. MEPCE recommends routing the discharge piping either to the exterior or to an indirect waste receptor such as a floor drain.

Drain pan valve

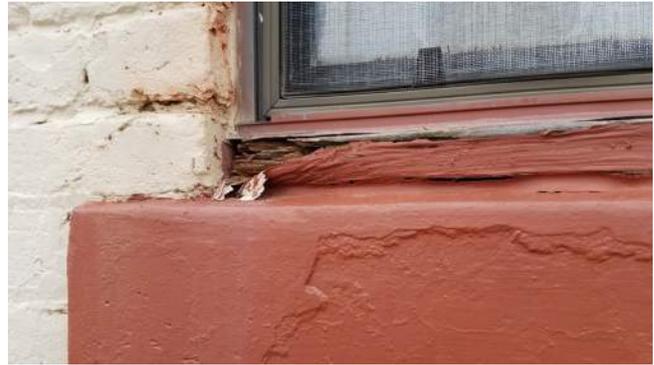
Deteriorated window sill

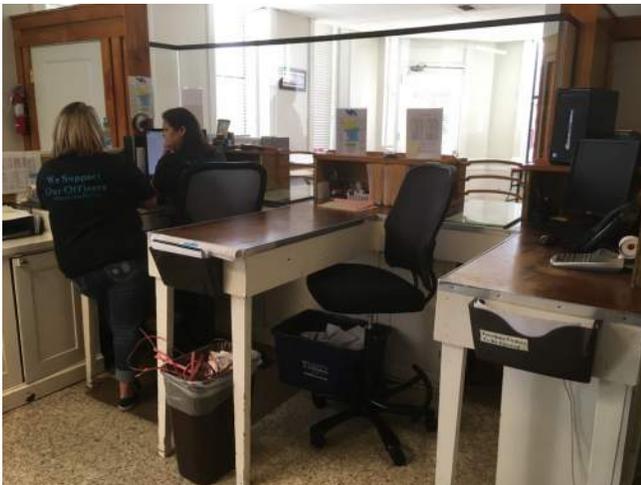
Unsecured clerk window

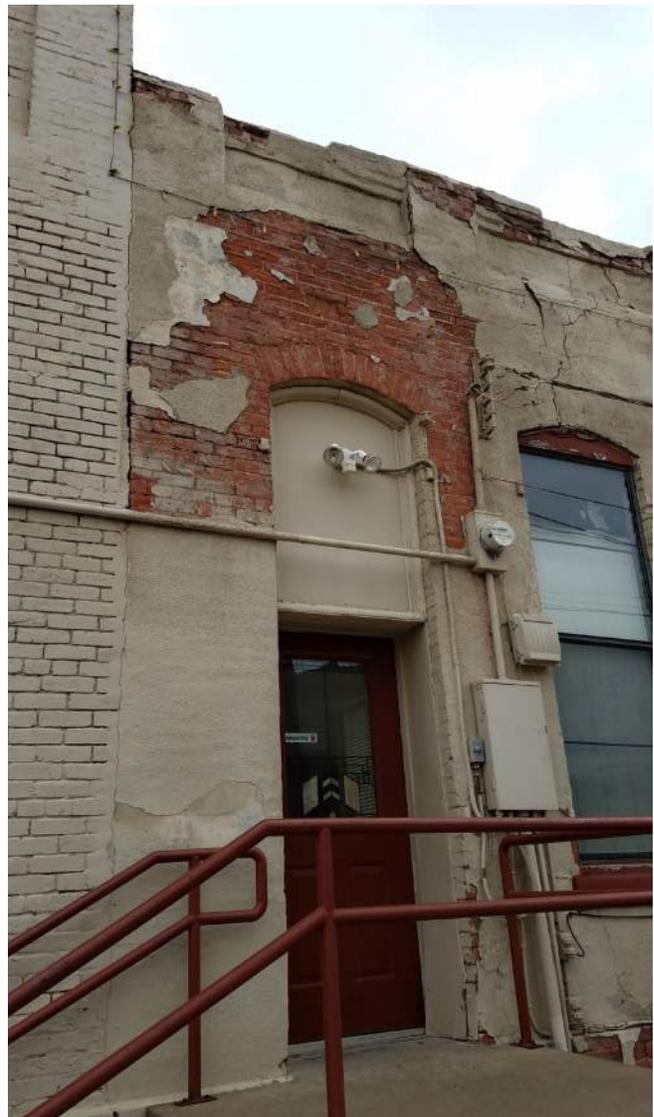
Poor facade condition

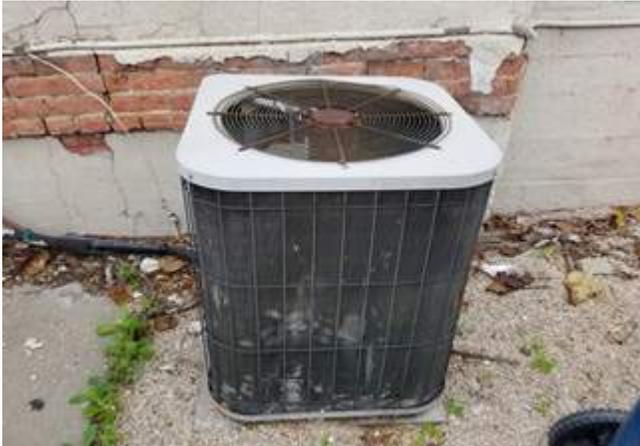
Aged 4-ton condensing unit

The main mechanical system consisting of the condensing unit and gas furnace unit are aged and in need of immediate replacement. MEPCE recommends a reassessment of the heating/cooling load and resizing the split system as required. A new energy efficient and properly sized unit would save in annual electricity bills and allow the portable units to only be used in case of emergency. The use of a ducted return with outside air intake would require architectural changes to the mechanical closet. MEPCE recommends installing aluminum jacketing along with new refrigerant piping and insulation when installing the replacement split system.

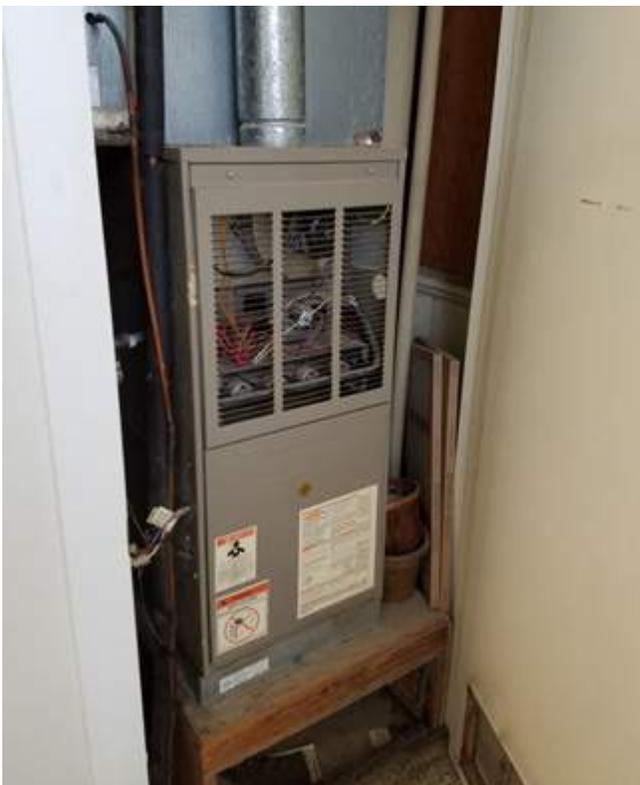
100-MBH heating is supplied by a gas-furnace unit located in the mechanical closet. There is no outside air provided to the gas furnaces unit. The gas furnace returns air through a louvered door while air is supplied above the ceiling.

Aged 100-MBH gas furnace unit

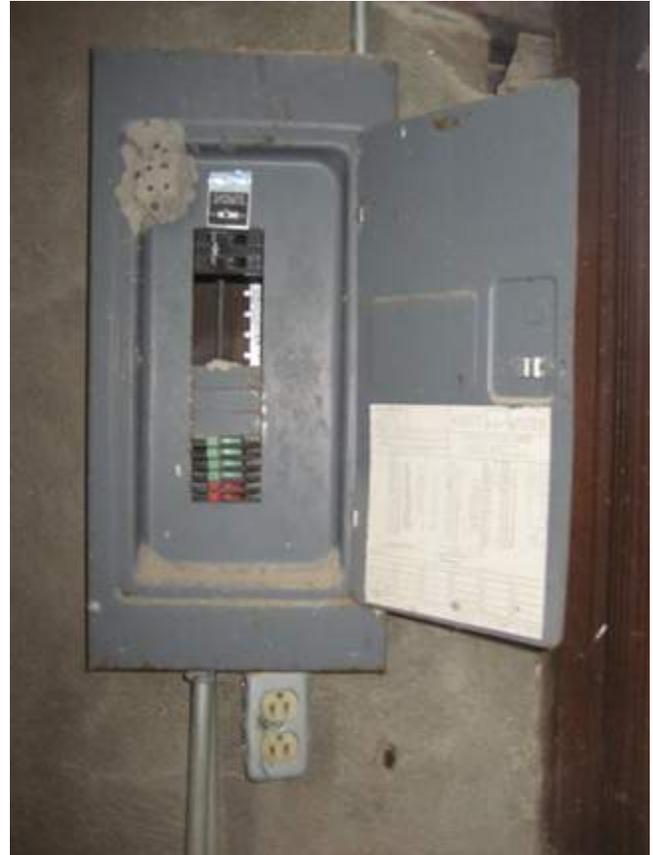
Overall the condition of the electrical system within the space is poor. The system is aged and the service entrance is undersized even with the second floor not being operational.

Second floor panel

MEPCE would recommend upgrading the service entrance size and replacing all electrical equipment within the space. It is not feasible to renovate a system of this age due to how difficult it is to acquire spare parts. Based on the dates observed on the nameplates the system is approximately 50 years old.

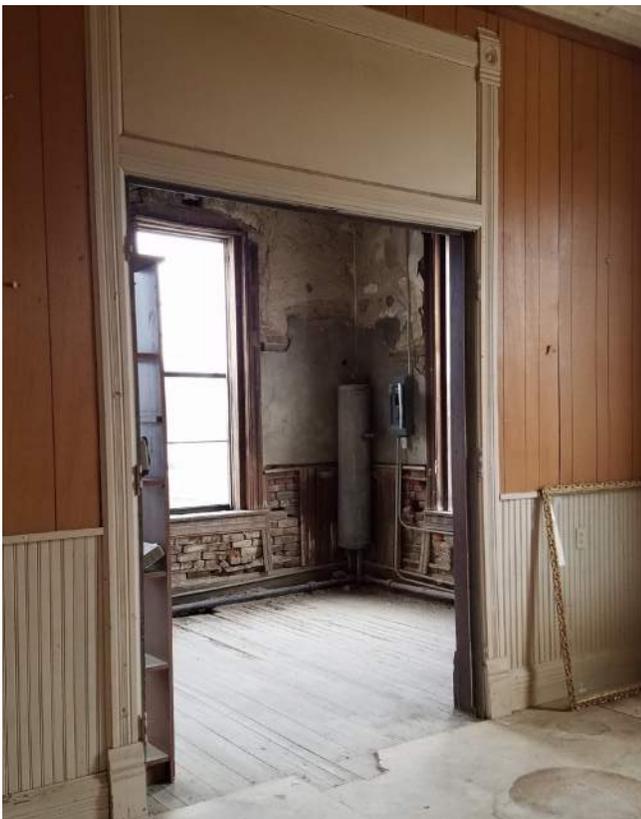
The second floor space is severely damaged and in need of complete renovation for any potential future use.

Second Floor City Hall

The City Hall Building was previously assessed by Structures PE, LLP in December of 2014. All observations, rendered opinions, and recommendations made in the 2014 report regarding the structure still apply to the building's current condition. If the building is to remain occupied, a more comprehensive assessment is still recommended within the next year to further evaluate the extent of the building's deterioration, water damage, and fire damage in order to provide pricing estimates for repair work and to restore the upper level to a habitable space.

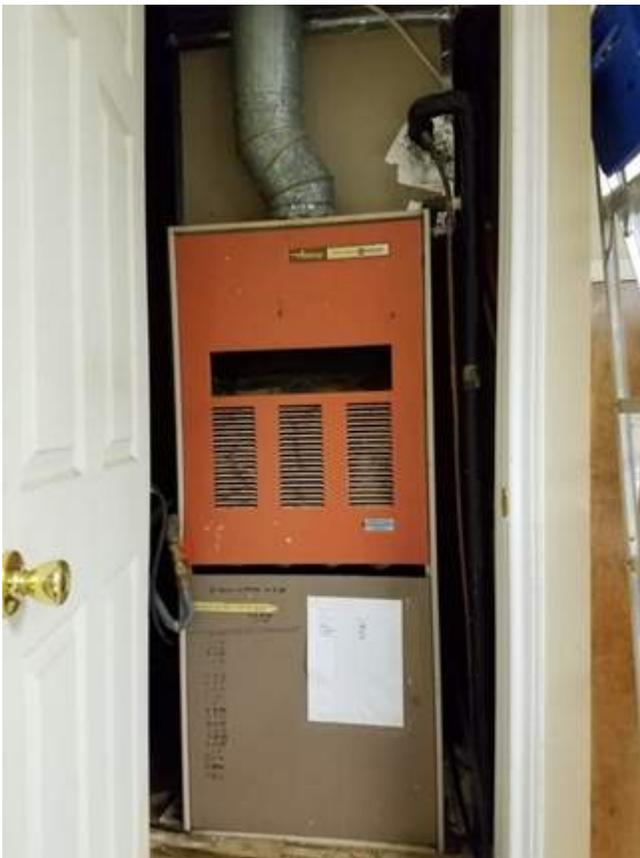
Aged gas furnace unit

The aged split system is aged and well past its recommended service life. The condensing unit is 16 years old and the gas furnace unit is 31 years old. MEPCE recommends replacement of this system within the next three years. The two other Rheem condensing units and gas furnaces manufactured in 2005 use R22 refrigerant and will need to be replaced within the next five to ten years. R22 refrigerant is currently being phased out of manufacturing and construction use. MEPCE recommends replacing damaged refrigerant suction line insulation and providing aluminum jacketing for the exposed refrigerant suction line insulation. Aluminum jacketing will protect the insulation and ensure the condensing unit continues performing efficiently.

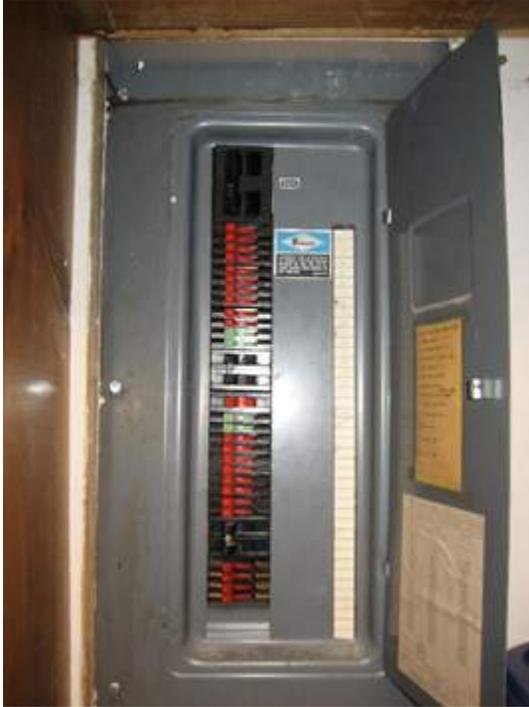
There are two main distribution panels within the space. One panel, which was installed during the original construction of the building, has a capacity of 225A at 120/240V and is located within the kitchen area. This panel is aged and out of date and has frequent issues with breakers tripping.

Kitchen Panel

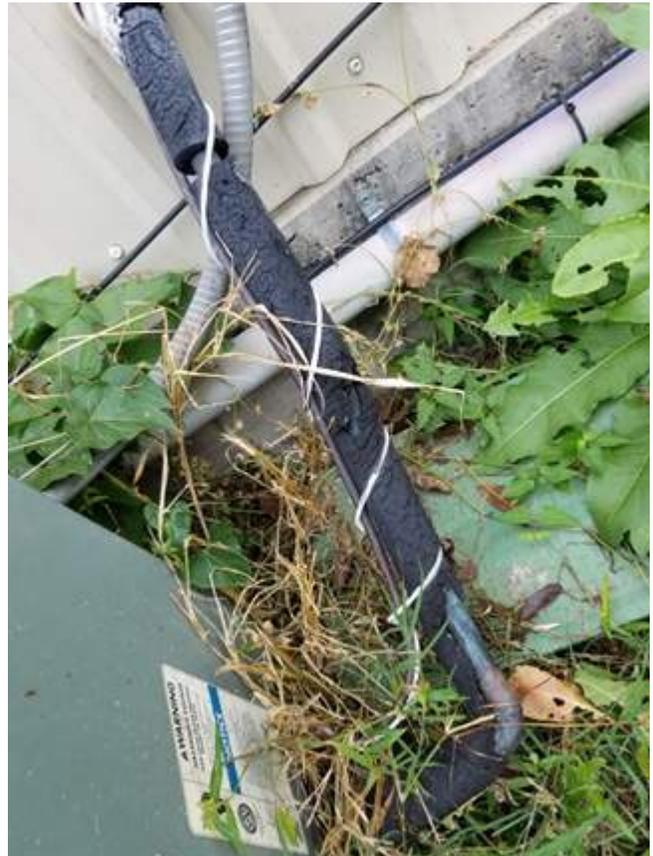
Damaged refrigerant insulation

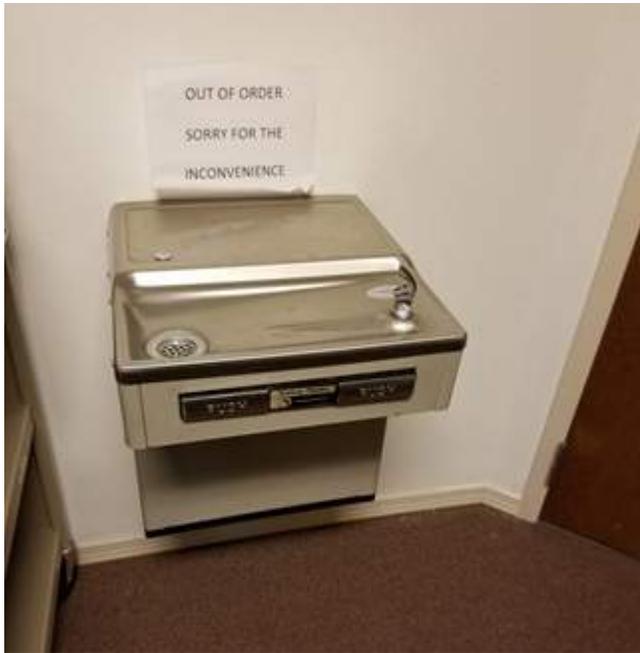
One of the electric water coolers is non-functional and is in need of repair or replacement.

Non-functional electric water cooler

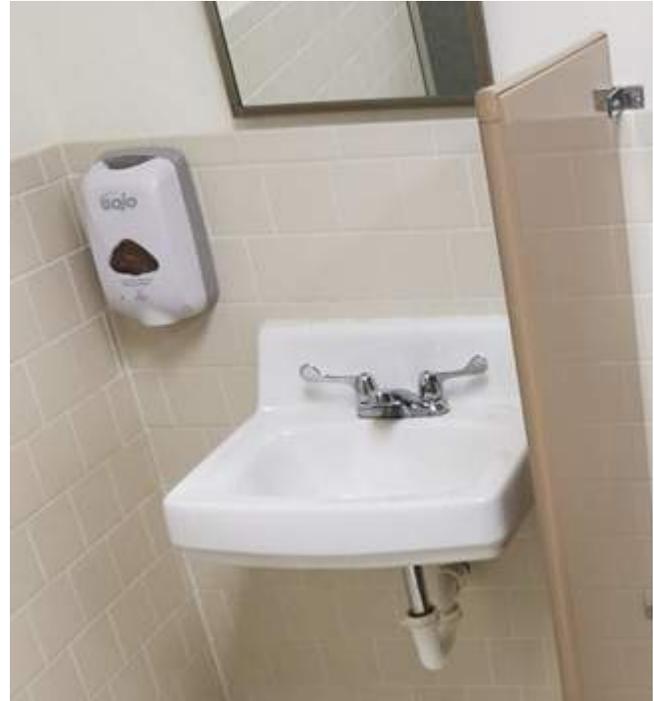
The men's restroom lavatory faucet discharges water with a distinct sulfur smell. A potential solution to this issue would be the installation of a charcoal filter.

Men's Lavatory

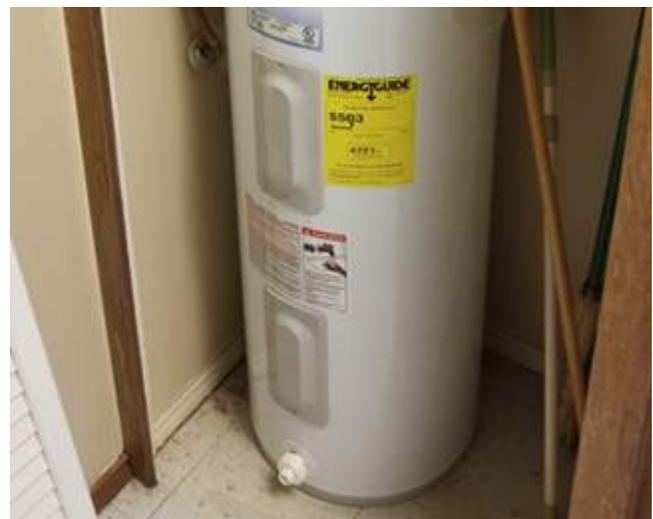
The water heater located in the kitchen does not have a drain pan, which is an international plumbing code (IPC) violation. A water heater failure and spill would cause damage to the flooring and walls. We recommend installing a drain pan and terminating the potential waste from the drain pan through an exterior wall.

Kitchen water heater

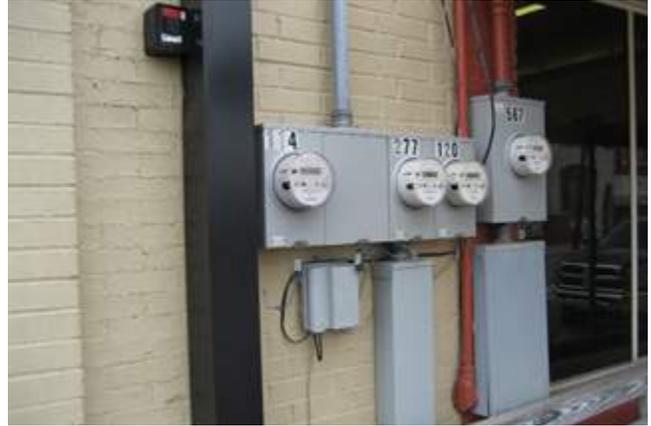
The main distribution panel with a capacity of 200A at 120/240V is located on the exterior adjacent to the utility meter and delivers power to mechanical equipment and a small distribution panel within the back of the space. The main panel is out of date and is in poor condition.

Electrical service entrance

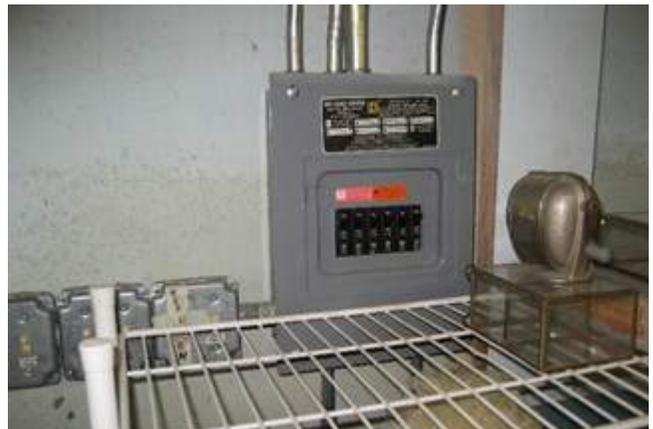
There was a smaller branch circuit panel within the space provides 120V circuits to convenience outlets. This panel is also out of date and in poor condition.

Branch Circuit Panel

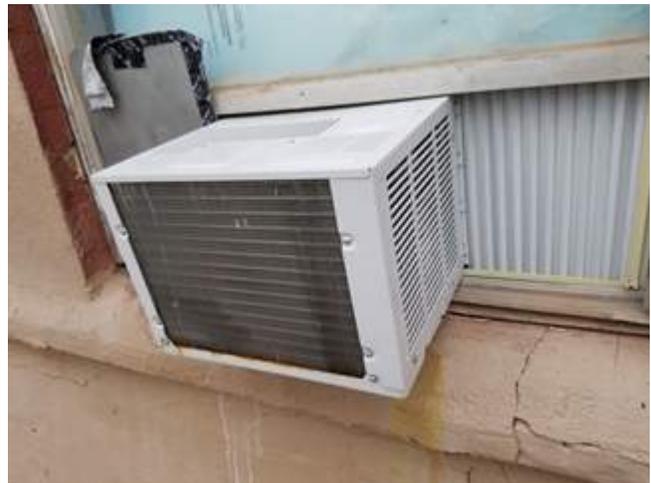
Aged PTAC unit

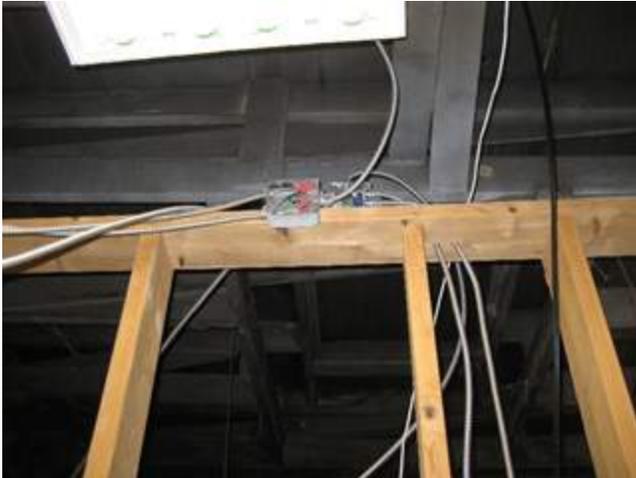
Exposed live parts

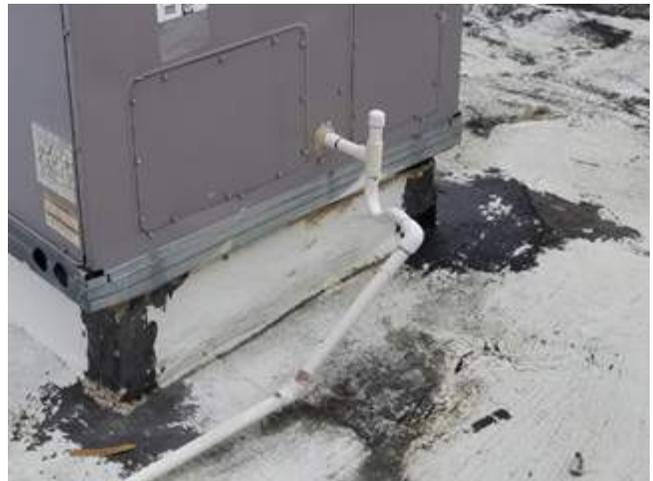
Broken condensate piping

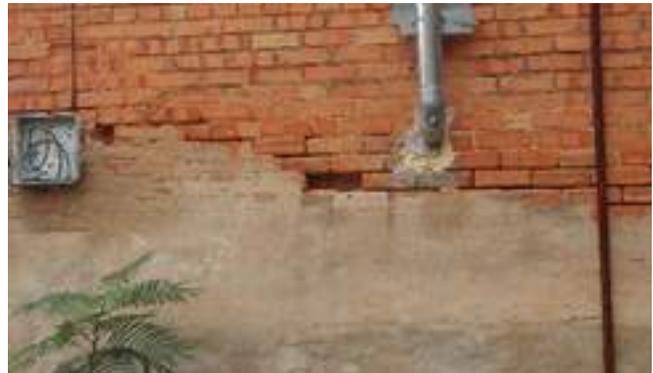
Damaged masonry wall

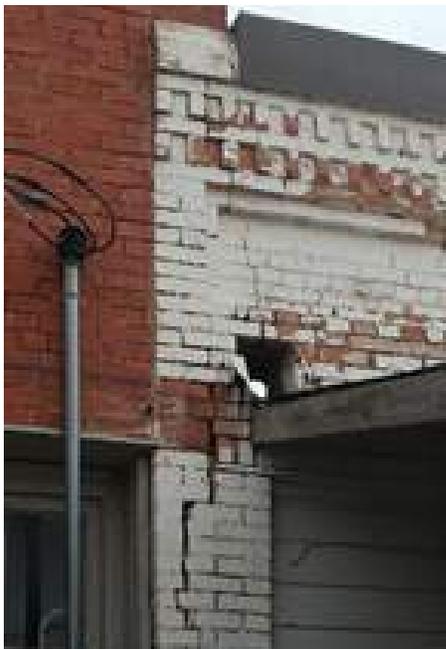
Damaged masonry wall

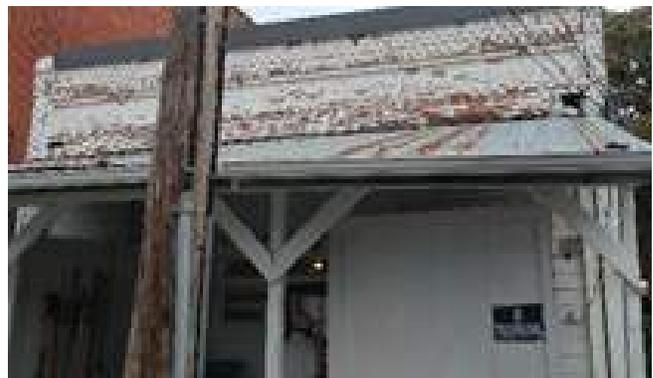
Settled wood shed roof
