Van Alstyne, Texas Municipal Space Needs Study

December 12, 2016

Van Alstyne Municipal Space Needs Study

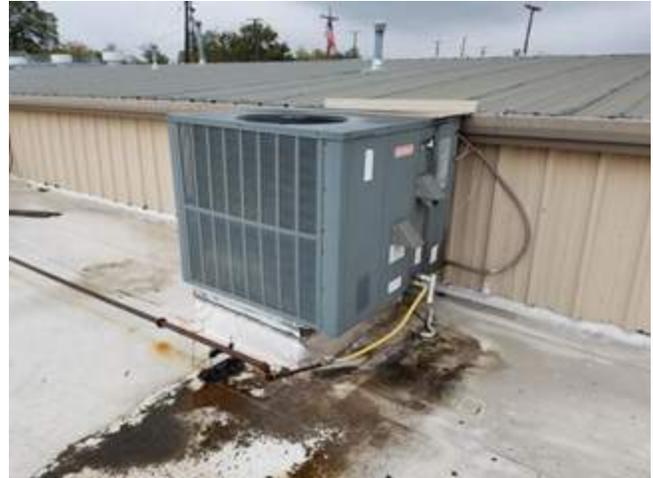
The mechanical equipment consists of two direct-expansion horizontal discharge packaged rooftop units with gas heating, three ductless split condensing units and five wall-mounted ductless fan coil units. Both packaged units are located on the roof while the condensing units are pad mounted along the exterior of the building. The packaged unit manufactured by International Comfort Products has a 3-ton cooling capacity, 80-MBH gas heating input and was manufactured in 2007. The packaged unit manufactured by Goodman has a 4-ton cooling capacity, 92-MBH gas heating input and was manufactured in 2009.

Goodman packaged unit

The packaged rooftop units both use R22 which is going out of production in 2020. The units need to be replaced within the next five to ten years. The Goodman packaged unit has a broken condensate pipe. The condensate pipe needs to be replaced and the waste needs to be routed to the existing scupper.

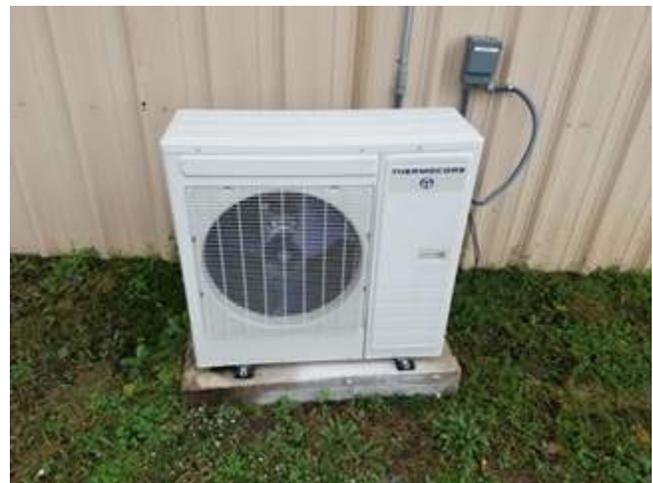
All ductless heat pump systems were installed recently and were manufactured by Thermocore. One of the systems has a single outdoor heat pump unit which connects to three separate wall-mounted fan coil units. All connections, refrigerant insulation and fan coil units are in excellent condition. This system has cooling and heating capacities of 2.25-ton with 0.75-ton each wall-mounted fan coil unit. The two other heat pump systems have single refrigerant connections and connect to single wall-mounted fan coils. These heat pumps have cooling and heating capacities ranging from 1.5-ton to 2-ton. Each fan coil unit has a remote control for thermostat controls.

Typical outdoor heat pump

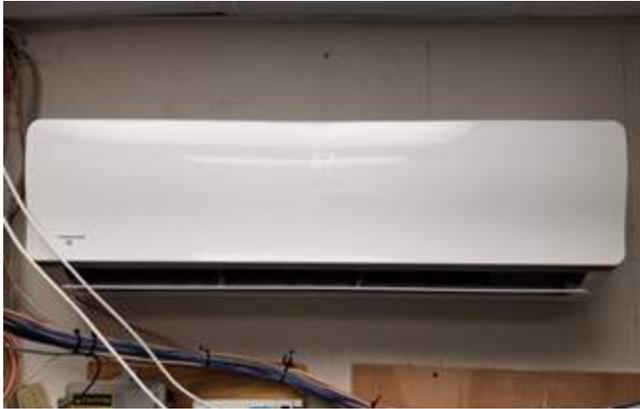
Typical wall-mounted fan coil unit

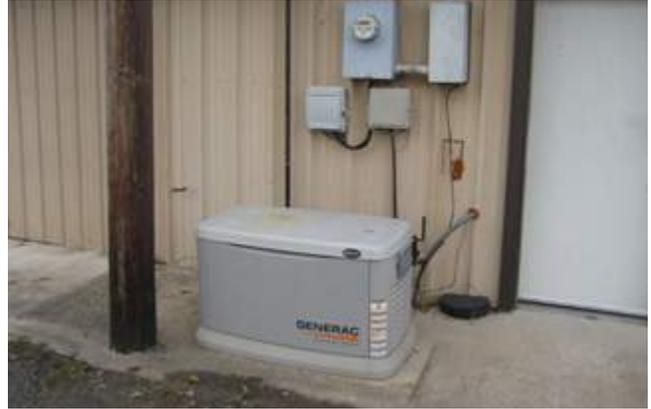
Emergency Generator

The entire electrical system is on emergency generator backup. This is controlled by a manual transfer switch. The emergency system appears to be in good condition.

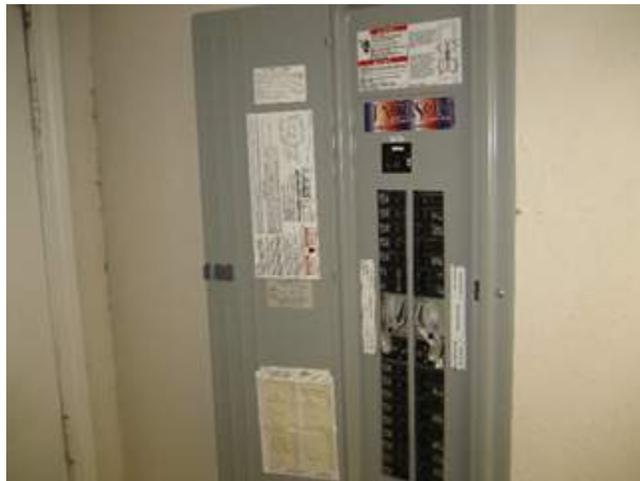
The electrical system is being powered from a single phase overhead primary which feeds an exterior meter located on the east side of the building. The main distribution panel with a capacity of 200A at 120/240V is located on the interior of the building within the corridor and delivers power throughout the entire building. The panel is in good condition but it was stated by the staff the breakers trip frequently.

Main Panel

The electrical system is in fair condition but is aged and out of date. MEPCE would recommend monitoring all electrical equipment and in the case of a renovation, replace all electrical equipment and assess the service entrance size. It is not feasible to renovate a system of this age due to how difficult it is to acquire spare parts. Based on the dates observed on the nameplates, the system is approximately 35 years old.

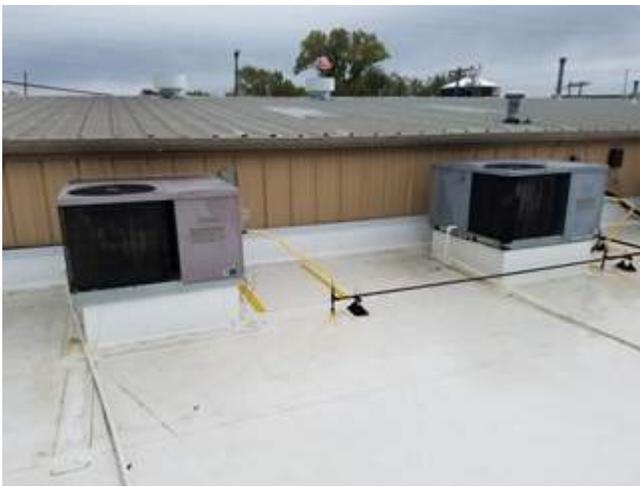
The mechanical equipment consists of two direct-expansion horizontal discharge packaged rooftop units with gas heating, two gas-fired unit heaters and one direct expansion split system. Both packaged units and the one condensing unit are located on the roof. Both packaged units have cooling capacities of 3-ton and heating capacities of 80-MBH. Both packaged units were manufactured by International Comfort Products, one in 2001 and the other in 2003.

Packaged units

All main mechanical equipment is aged and in need of replacement within the next three years. Both packaged units have low efficiency ratings of 10 SEER and use soon to be obsolete R22 refrigerant. The split system also uses R22 and has been derated from years of use. The non-functional unit heater should be replaced immediately while the working unit should be planned for replacement in the next three years. MEPCE recommends a reassessment of the heating/ cooling load and replacement of the entire mechanical system including equipment, ductwork, air devices and accessories.

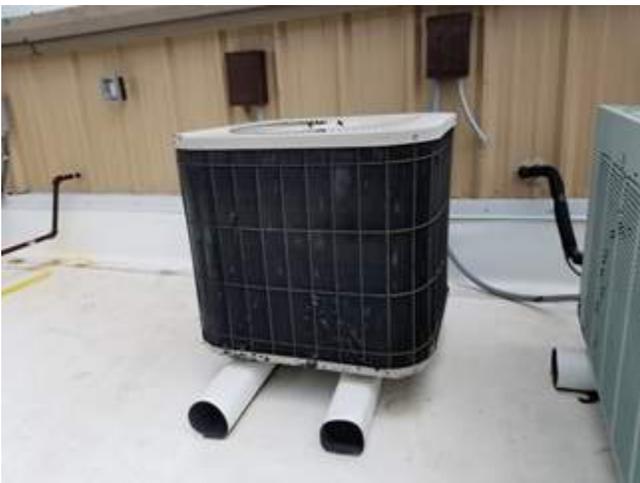
The condensing unit located on the roof and has a cooling capacity of 4-ton. The condensing unit was manufactured by Goodman in the year 2000.

Condensing Units

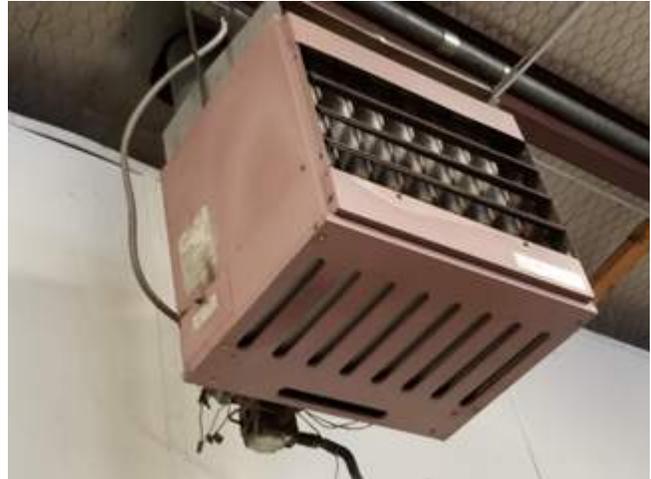
The unit heaters are located in the apparatus bay and each have a heating capacity of 105-MBH. One of the unit heaters is non-functional according to the department staff. Both unit heaters were manufactured in 1984.

Gas-fired unit heater

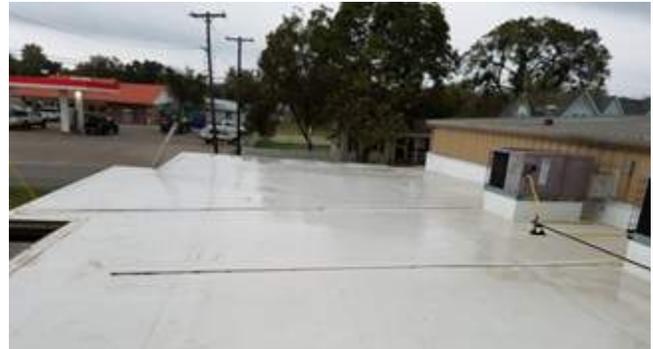
The condensate drain piping for the packaged units is not properly supported or sloped leading to constant water dripping onto the recently renovated roof. The condensate drains also are lacking vented P-traps, which is an international plumbing code (IPC) requirement.

Condensate piping

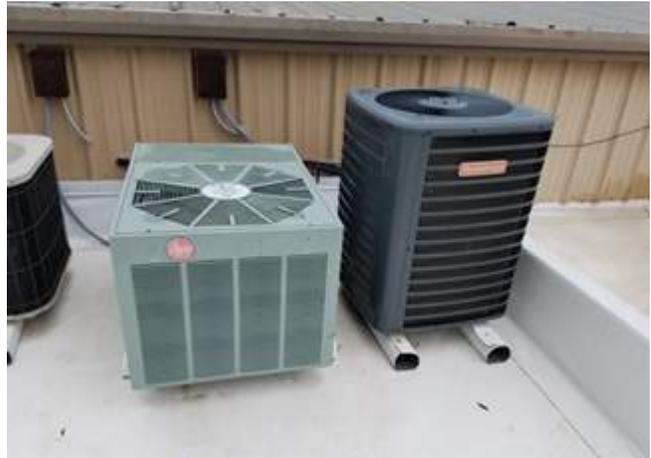
The mechanical equipment consists of two direct-expansion split systems. Both condensing units are located on the roof. The aged Rheem unit has a capacity of 4-ton while the newer Goodman unit has a capacity of 5-ton. The Rheem unit was installed around the year 2000 while the Goodman unit was installed recently around the year 2015.

Condensing Units

The 4-ton split system consisting of the Rheem condensing unit and gas furnace unit are aged and in need of replacement within the next three to five years. Humidity issues were reported by the building staff. MEPCE recommends a reassessment of the heating/cooling load and resizing the aged split system to properly deal with the current humidity issues. MEPCE recommends providing aluminum jacking for the exposed refrigerant suction line insulation. Aluminum jacking will protect the insulation and ensure the condensing units continue performing efficiently.

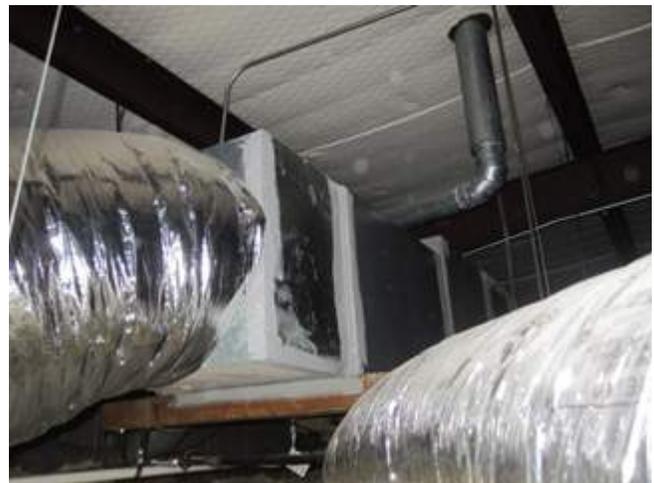
Two gas furnace units are located above ceiling and pair with the rooftop condensing units. Heating capacities of 100-MBH are estimated for each unit. There is no outside air provided to either gas furnaces unit. The gas furnaces are installed in “residential style”, meaning there is no rigid duct installed. There is a plenum box on the inlet and discharge of each gas furnace unit, with flexible duct routed separately to each air device.

Gas furnace unit located above ceiling

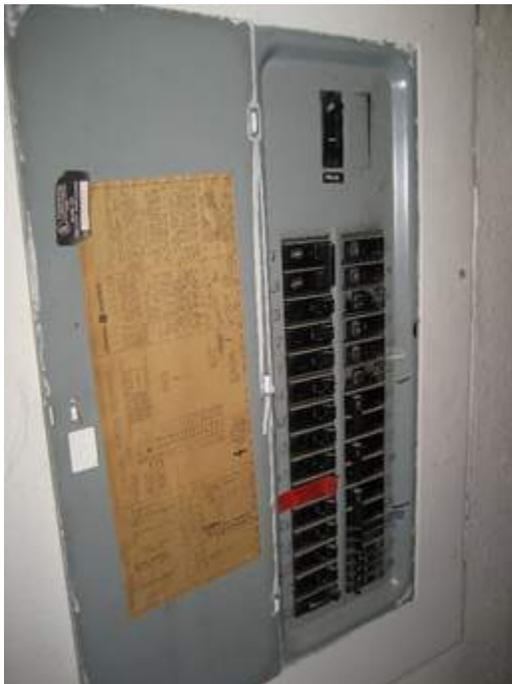
The main distribution panel with a capacity of 200A at 120/240V is located within the Fire Department truck bay and delivers power throughout the entire Community Center space.

Distribution Panel

The electrical system is in fair condition but is aged and out of date. MEPCE would recommend monitoring all electrical equipment and in the case of a renovation, replace all electrical equipment and assess the service entrance size. It is not feasible to renovate a system of this age due to how difficult it is to acquire spare parts. Based on the dates observed on the nameplates, the system is approximately 50 years old.

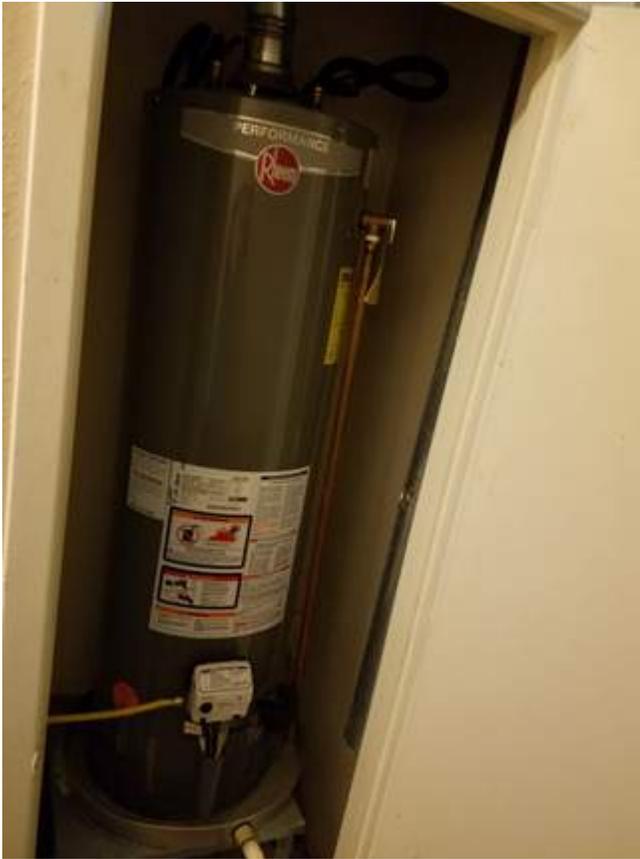
The building has public restrooms for men and women which have counter-mounted sinks, gravity flush tank water closets and wall-mounted flush valve urinals. All plumbing fixtures appear to be in good condition. Both restrooms also have floor drains. Hot water is supplied by a gas-fired tank type water heater located in a dedicated closet near the public restrooms. The water heater has a capacity of 40-gallons with 36-MBH gas heating input. The water heater was installed in 2014 and is in good condition.

Gas-fired water heater

The water heater temperature and relief valve is routed directly into the drain pan. The drain pan valve is routed to the floor. This current configuration could cause damage to the flooring and walls. MEPCE recommends routing the discharge piping either to the exterior or to an indirect waste receptor such as a floor drain.

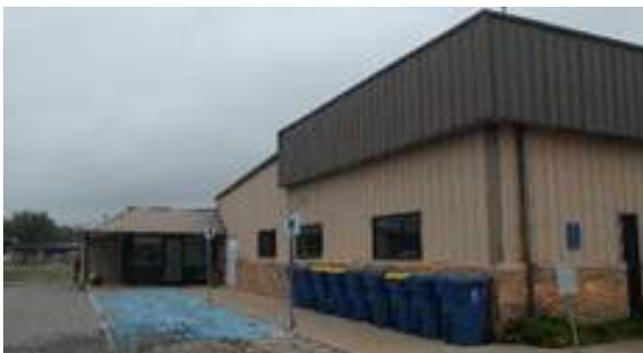
Pre-Engineered Metal Building

Access to view the pre-engineered metal building roof structure and columns behind the architectural finishes was limited. Based on the observed roof structure in the drive bays of the Fire Station and the roof structure above the ceiling tiles in the Community Center, the structure does not appear to have any major structural concerns.

Discussions on site with the City Manager, Frank Baker, included mention of a 2014 storm that caused ceiling deflections on the order of 1'-0" due to ice on the roof. The structure was supposedly reviewed by a structural engineer after the ice had melted and the roof purlins and beams were determined to be structurally acceptable as they returned to their original elevations.

Various roof leaks have also created damage to interior ceilings and finishes but no signs of structural deficiencies are present at this time. Signs of roof leaks, primarily exposed by discoloration of ceiling tiles, should continue to be monitored and repaired as they are discovered.

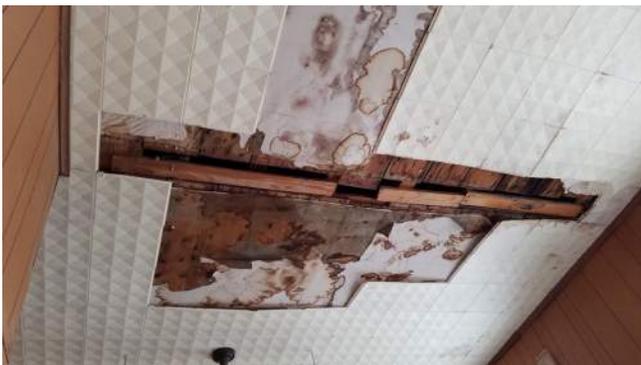
Water damage from improper roof flashing

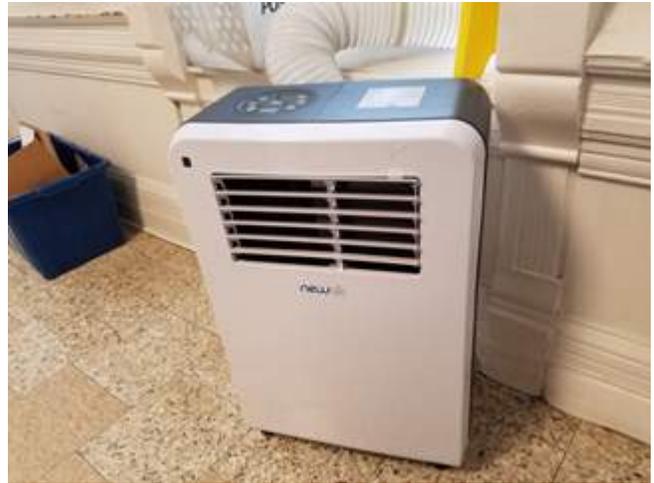
Portable air conditioner

The four 1-ton portable air conditioners were purchased recently to remedy the ineffective split system.

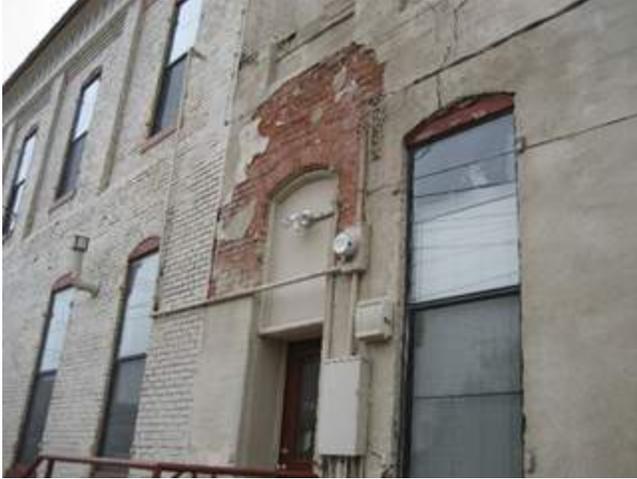
Electrical Service Entrance

The main distribution panel with a capacity of 200A at 120/240V is located on the exterior adjacent to the utility meter and delivers power throughout the entire building. The panel is out of date and undersized for the requirements of the building. It was noted that the main circuit breaker would frequently trip, turning off power to the entire space, during peak hours.

Overall the condition of the electrical system within the space is poor. The system is aged and the service entrance is undersized even with the second floor not being operational.

MEPCE would recommend upgrading the service entrance size and replacing all electrical equipment within the space. It is not feasible to renovate a system of this age due to how difficult it is to acquire spare parts. Based on the dates observed on the nameplates the system is approximately 50 years old.

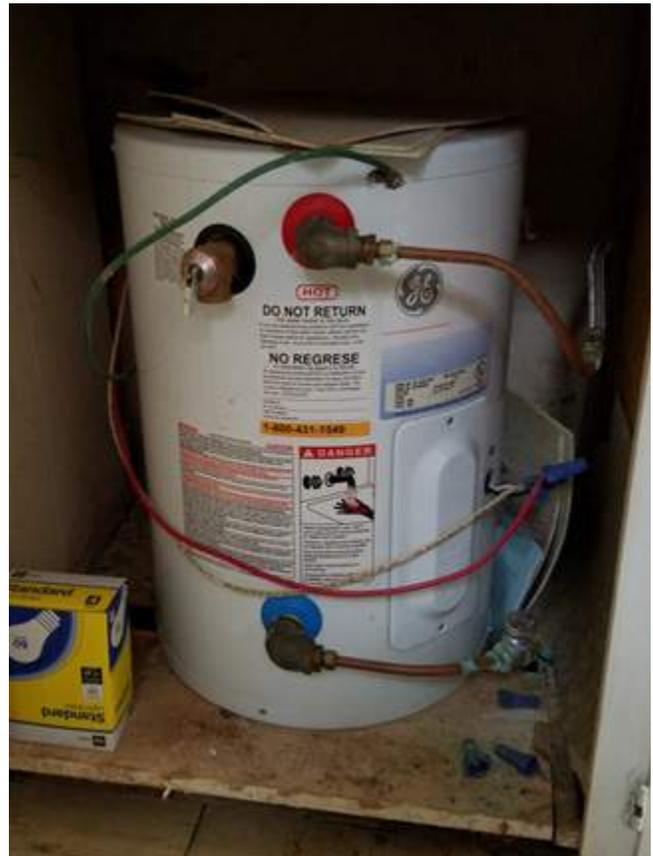
Lowboy water heater

Hot water is supplied by an electric lowboy water heater located underneath the counter. The water heater has a capacity of 10-gallons with 2-kw heating. The water heater was manufactured in 2010 and is in good condition.

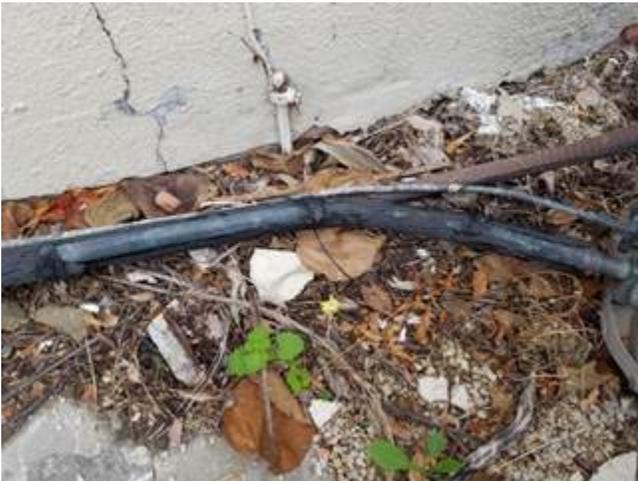
Existing refrigerant piping

The main mechanical system consisting of the condensing unit and gas furnace unit are aged and in need of immediate replacement. MEPCE recommends a reassessment of the heating/cooling load and resizing the split system as required. A new energy efficient and properly sized unit would save in annual electricity bills and allow the portable units to only be used in case of emergency. The use of a ducted return with outside air intake would require architectural changes to the mechanical closet. MEPCE recommends installing aluminum jacketing along with new refrigerant piping and insulation when installing the replacement split system.

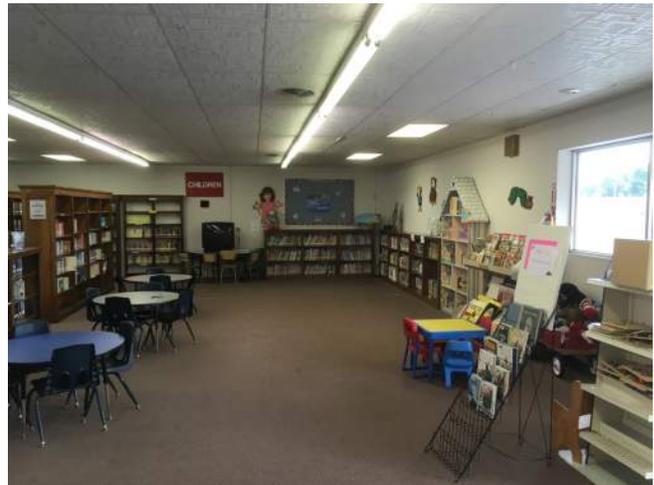
Children's Program Area

- There is not a designated public meeting room
- The children's program area is not large enough to support current programs
- There is not a dedicated staff/volunteer work room
- The storage space in the existing facility does not meet the current needs
- There is not adequate study and reading seating

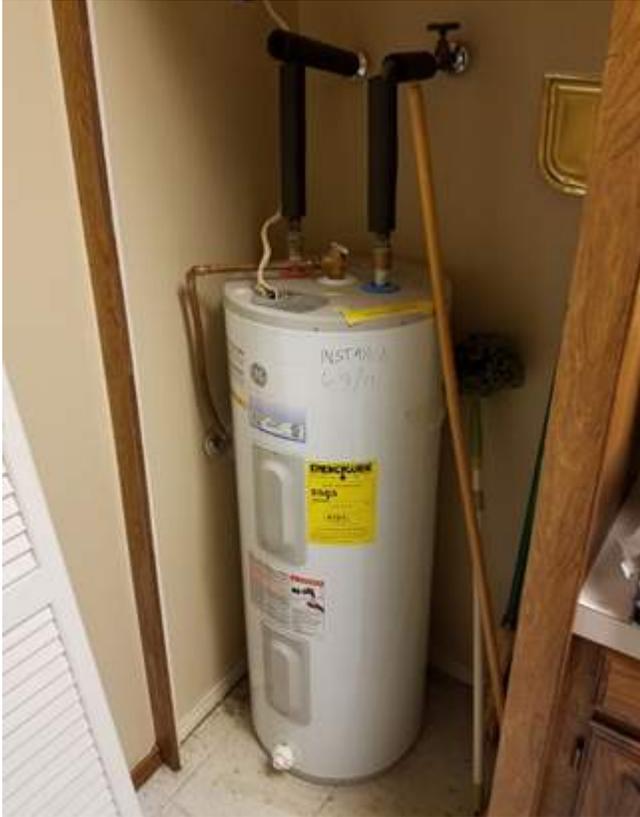
Kitchen water heater

The water heater located in the kitchen does not have a drain pan, which is an international plumbing code (IPC) violation. A water heater failure and spill would cause damage to the flooring and walls. We recommend installing a drain pan and terminating the potential waste from the drain pan through an exterior wall.

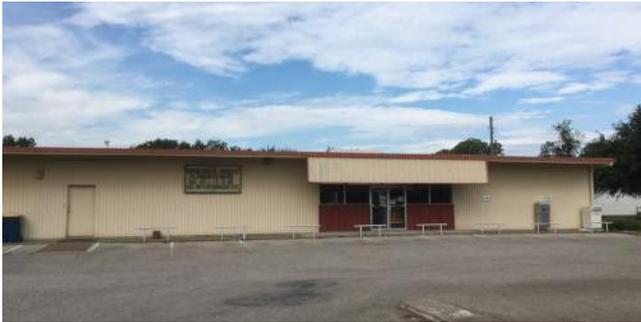
- There is no dedicated staff parking for Library staff
- The book return is not a drive thru, requiring guests to exit their vehicles to return merchandise.
- The parking lot is divided with no clear demarkation of the main entrance

Staff Parking and Book Return

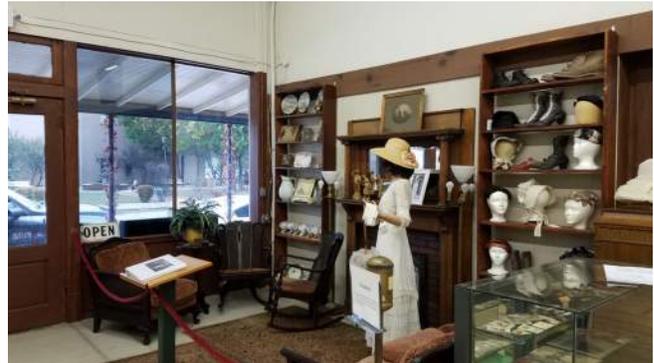
Existing Museum Collection

The City of Van Alstyne’s museum is located at 214 E Jefferson Street. This facility is a time capsule of the city’s long history. This one story structure is 2,344sqft. The current collection has maximized the existing building footprint and will need to be relocated to accommodate future growth.

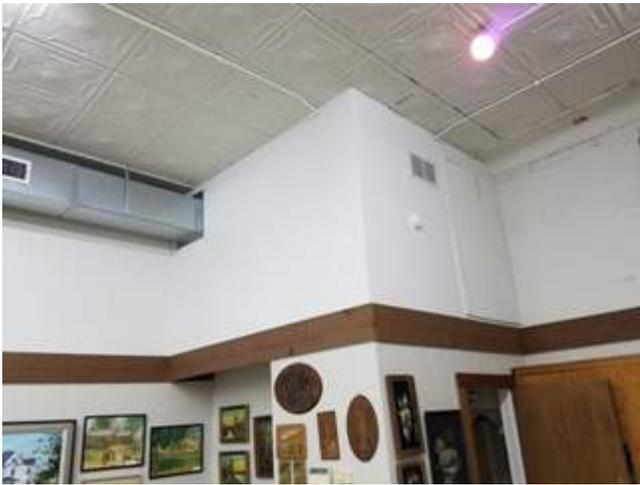
Unit enclosure and exposed ductwork

The indoor unit was inaccessible due its location above the restroom. A ladder is required to reach the access panel. The unit is assumed a gas furnace unit with 100-MBH heating input. This location makes maintenance difficult. The unit has air supplied through exposed ductwork along the

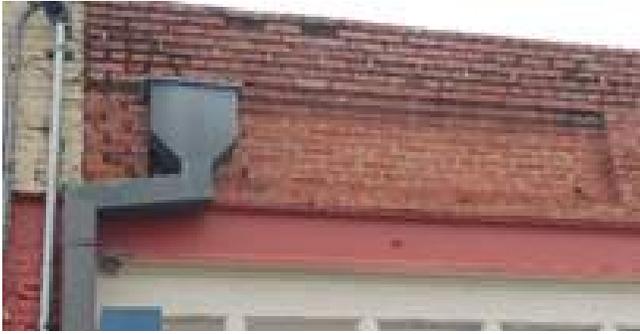
Damaged brick facade

However, many historic buildings from the late 1800's and early 1900's have noticeable deterioration of the exterior load-bearing bricks and mortar. The top of the parapet along the front north face of the museum shows signs of deterioration and discoloration of the bricks due to age and water exposure. It is likely that portions of the brick walls will require repointing and replacement of bricks based on the weathering impacts seen on the outside face of the exterior walls. All soft and disintegrated mortar shall be removed and replaced with a comparable lime mortar and shall be performed by a qualified mason with experience in historic building repairs.

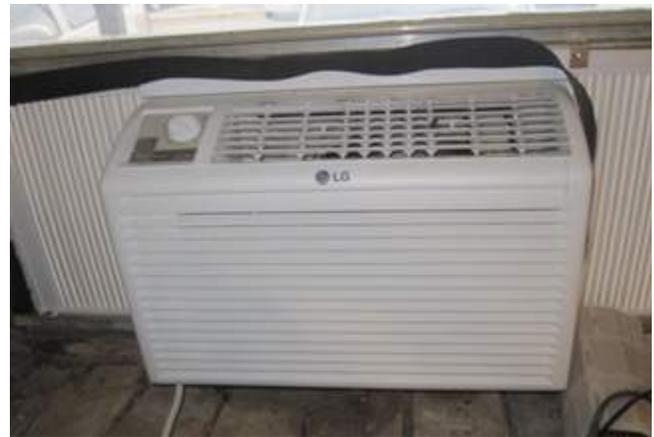
PTAC unit

The mechanical equipment consists of two packaged terminal air conditioning (PTAC) window units and gas-fired unit heater. The PTAC units serve the two office spaces. The restroom and main storage area is served by the gas-fired unit heater.

The building has a limited mechanical system. The unit heater and one of the PTAC units were aged (at least 10 years of use) and should be planned for replacement within the next five years.

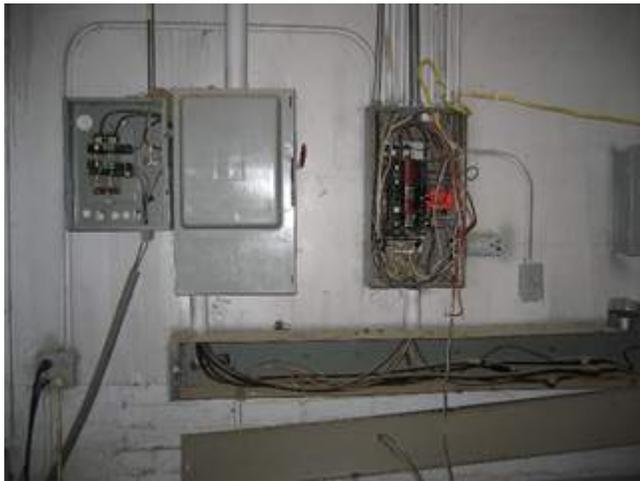
Main distribution panel

The service entrance is split to feed the SCADA system as well as the main distribution panel. The main panel with a capacity of 200A at 120/240V is located on the interior delivers power throughout the entire building. The panel is out of date and is a life safety issue due to exposed live parts. It was noted that fuses are frequently being blown.

Overall the condition of the electrical system within the space is poor. The system is aged, a potential fire hazard, and needs to be replaced.

MEPCE would recommend upgrading the service entrance size and replacing all electrical equipment within the space. It is not feasible to renovate a system of this age due to how difficult it is to acquire spare parts. Based on the dates observed on the nameplates the system is approximately 60 years old.

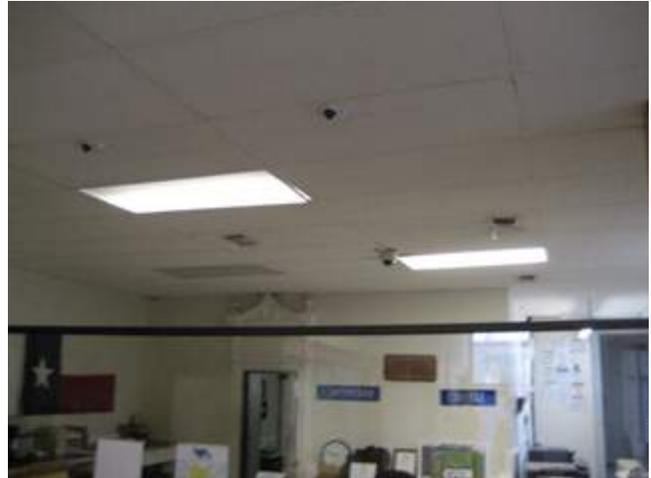
Interior Lighting

The exterior lighting of the building consists of an emergency fixture located above the egress doors. Linear fluorescent fixtures are being used to illuminate the interior space. The lighting is in poor condition and needs to be replaced.

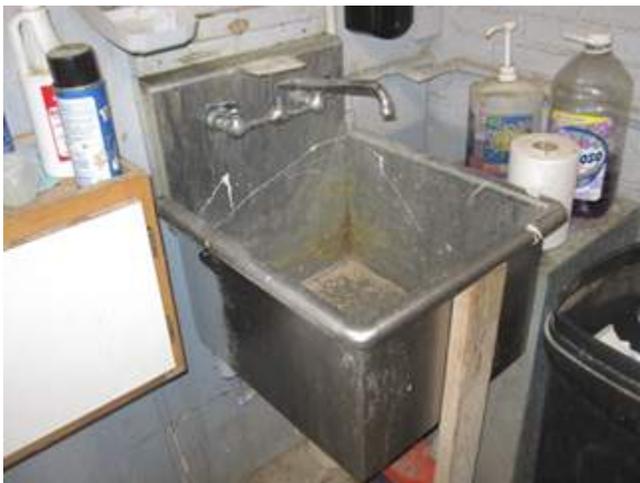
Wall - mounted sink

The wall-mounted sink is aged and discolored with paint and rust. The faucet is loosely fastened to the wall. MEPCE recommends replacing both the sink and faucet.

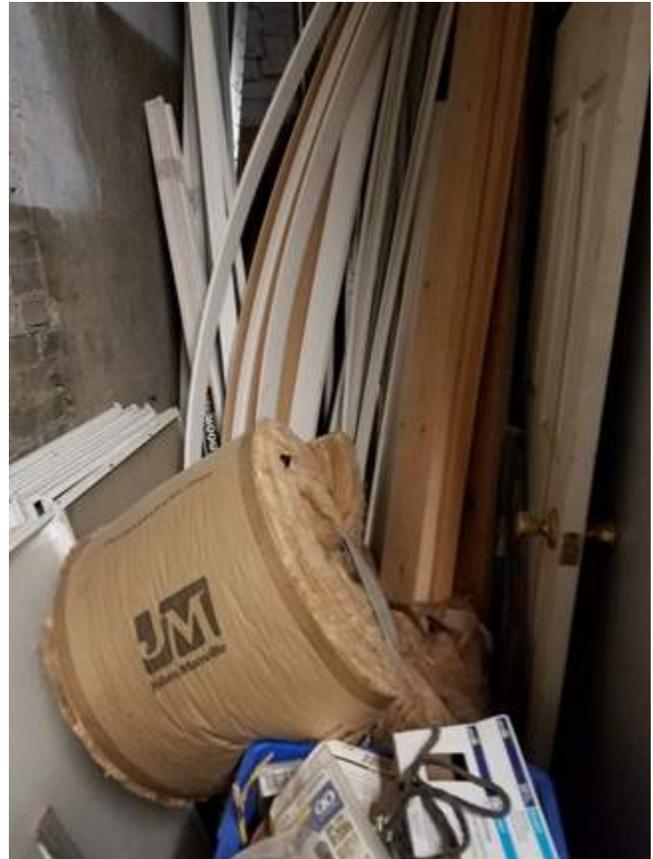
Water heater location

The water heater is operable but not used according to the facility staff. The water heater is covered with storage items and is inaccessible. The water heater should be uncovered and put into operation if the building staff plans to shower or wash with the wall-mounted sink.

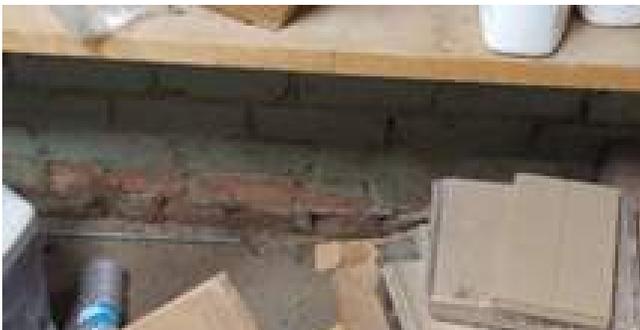
Damaged masonry wall

As previously noted, many historic buildings have noticeable deterioration of the exterior load-bearing bricks and mortar. The most significant deterioration is at the base of the masonry walls within the original fire truck bay. The lower courses of brick were likely exposed to more frequent wet-dry cycles when used as a fire truck bay. Exposure to moisture and temperature cycles will cause deterioration of the clay bricks and weaken the lime mortar significantly over time.

In addition, the paint and plaster applied to the exterior masonry walls has potentially increased the weathering and deterioration of the bricks and mortar. The various uses of the building, previous roof leaks, and visible signs of mortar deterioration reveal that water has infiltrated through the roof and walls. The brick and lime mortar wall system is unique in the way that moisture is transmitted through

the wall and evaporates to the exterior. The lime mortar is not brittle like cement-based mortar, but is much softer and more permeable. When painted or covered with a non-breathable paint, the mortar and brick hold moisture and the intended function of the wall is altered. Since the moisture cannot migrate through the mortar as intended, it is forced into the brick units and causes more rapid deterioration and weakening of the bricks.

The existing paint and final wall assembly recommendations should be reviewed by a qualified building enclosure specialist in order to provide a breathable wall assembly that will prolong the life of the structure. Additional information regarding cleaning and painting existing brick can be found in the article, “Technical Notes 6 – Painting Brick Masonry”, by the Brick Industry Association. The extent of masonry repair and reconstruction throughout the building shall be explored further by a qualified mason in order to locate and repair any compromised portions of masonry and to ensure the safety of the public and the city employees working in the building.

All mortar repairs shall be made from the inside of the building with a lime mortar mix that is comparable in strength and permeability to the existing mortar. A qualified mason with experience in historic structures should be used for further investigation and cost estimates. The use of cement-based mortar shall not be used to repair the walls and any caulk and cement-based mortar from previous repair attempts shall be removed.

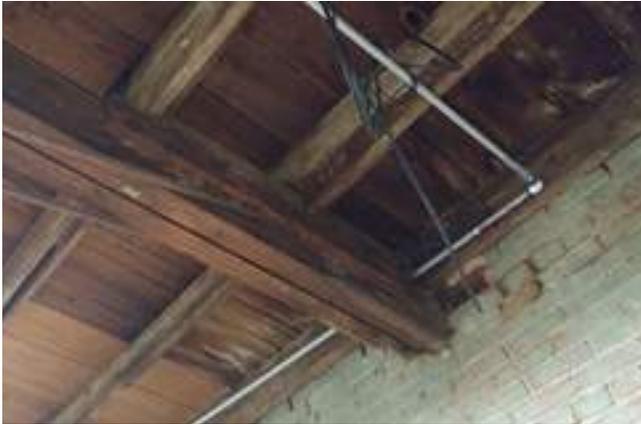
Wood roof framing

Generally, all of the wood framing within the building appears to be structurally sound. The pre-engineered roof trusses above the original roof structure were not observed. The original wood roof shows some signs of water damage,

discoloration, and some deterioration that is not uncommon given the history of the building. The bow string truss appears to be performing as intended and no structural concerns were noted.

Inspection of the original wood roof members was limited to visual observations. Although no signs of severe wood rot was observed from the ground, the various building occupants throughout history and the known roof leaks warrant a more detailed review of the wood to ensure past water damage has not caused hazardous levels of rot. This is not an immediate concern but is recommended to be addressed if any future work is performed on the building, preferably within the next 5 years.

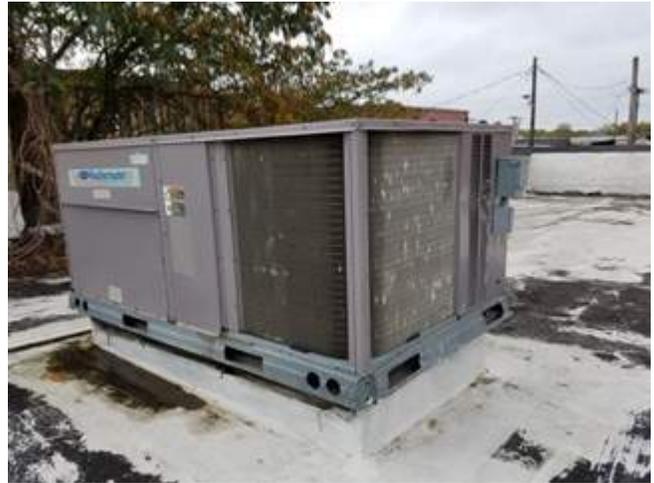
Packaged rooftop unit

The mechanical equipment consists of two 5-ton direct-expansion packaged rooftop units with 72-MBH gas heating. Both packaged units were manufactured by Carrier in 2004.

The 5-ton packaged units are aged and use R22 refrigerant. The units should be planned for replacement within the next five to ten years. Both packaged units have hail damaged fins. MEPCE recommends combing the fins and installing hail protection grilles. Damaged fins derate the units and lower efficiencies. The condensate piping is not properly supported and one of the condensate connections is broken; leaking directly onto the roof. MEPCE recommends replacing all condensate piping and supporting as required per the international plumbing code (IPC).

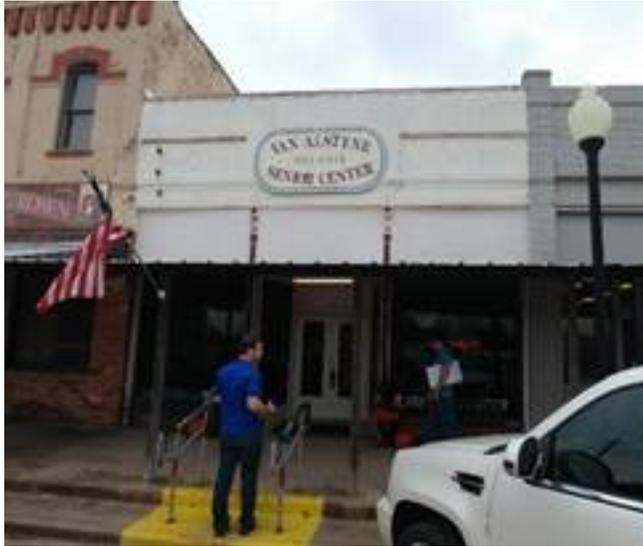
Limited street parking

- There are no dedicated Senior Center parking spaces. Currently, guests share parking with neighboring businesses and restaurants
- There are no volunteer or staff parking spaces

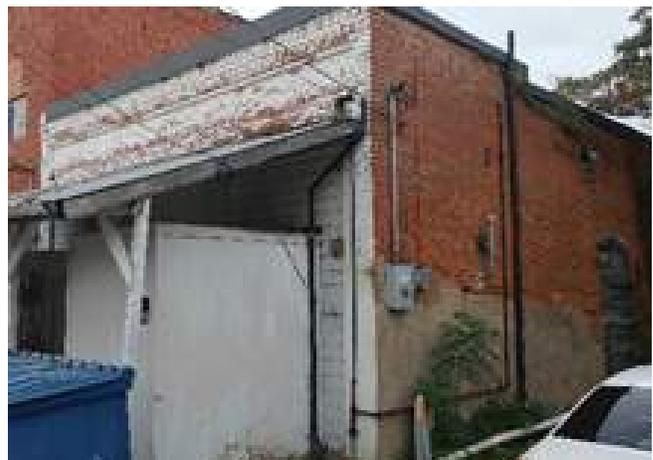
Painted masonry wall

The most significant deterioration was observed at the north and east masonry walls accessed from the alley behind the building. Stucco has been applied to the lower portion of the north masonry wall and the west entry façade. The east rear wall has also been painted. These additional coatings potentially increase the weathering and deterioration of the bricks and mortar. The brick and lime mortar wall system is unique in the way that moisture is transmitted through the wall and evaporates to the exterior. The lime mortar is not brittle like modern cement-based mortar, but is much softer and more permeable. When painted or covered with a non-breathable paint, the mortar and brick hold moisture and the intended function of the wall is altered. Since the moisture cannot migrate through the mortar and evaporate as intended, it is forced into the brick units and causes more rapid deterioration and weakening of the bricks.

The existing paint should be inspected further and removed if it is not a breathable paint product. A porous paint product or lime wash is recommended to allow moisture to escape the masonry wall and avoid accelerated deterioration of the bricks and mortar. Additional information regarding cleaning and painting existing brick can be found in the article, “Technical Notes 6 – Painting Brick Masonry”, by the Brick Industry Association. The partial stucco finish should also be removed to assess the condition of the brick and mortar behind the stucco.

The existing paint and final wall assembly recommendations should be reviewed by a qualified building enclosure specialist in order to provide a breathable wall assembly that will prolong the life of the structure. The extent of repair and reconstruction of the masonry shall be explored further by a qualified mason in order to locate and repair any structurally compromised areas. In addition, the large openings and cracks in the brick façade at the northeast and southeast corner of the building should be evaluated further and rebuilt as determined necessary by a qualified mason to restore the structural integrity of the wall and to prevent water intrusion. The crack appears to be caused by a combination of weak mortar and deteriorating clay bricks caused by water exposure over time and stress caused by the deflecting and inadequately supported shed roof that is attached to the rear brick wall.
